Entry into enclosed spaces; an ongoing issue

Why do accidents still occur?

Francisco Juarrero

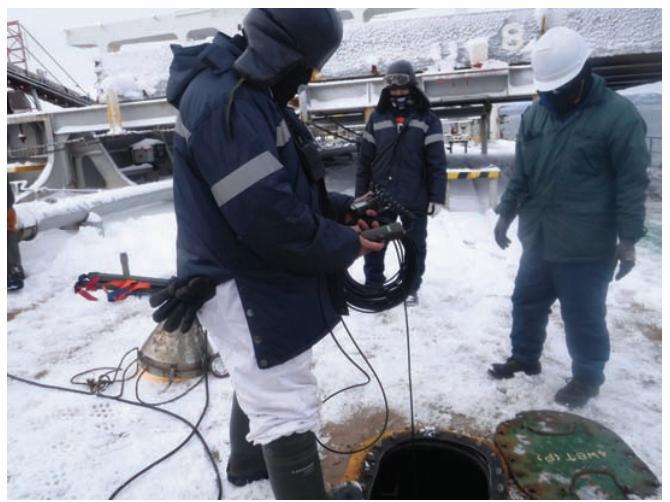
Monitoring the atmosphere inside the tank (Credit: F Juarrero)

However, as pointed out in section 10.7.2 of the International Safety Guide for Oil Tankers and Terminals (ISGOTT), ventilation is not an infallible solution. ISGOTT highlights the problem of possible pockets of gas where the air flow is less effective and prescribes as a solution measuring the atmosphere at the top, middle and bottom of the tank.

6.3.3 – The atmosphere of the space has been tested as appropriate with properly calibrated instruments to ascertain acceptable levels of oxygen and acceptable levels of flammable or toxic vapours.

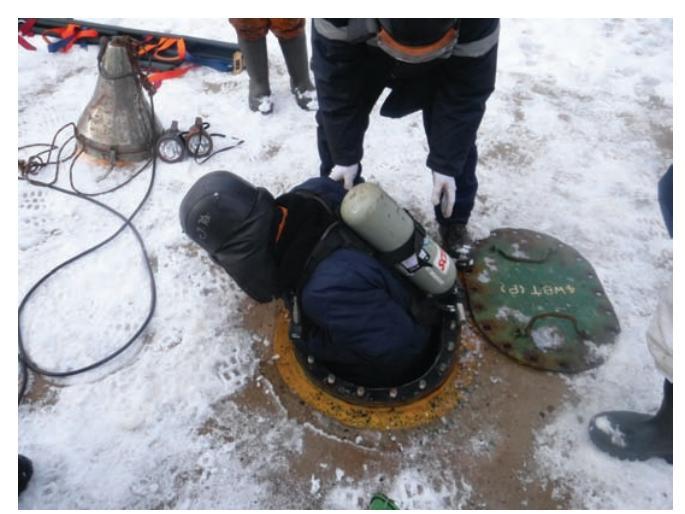
Operator having difficulties in entering the tank with SCBA

15.8.4 – Breathing equipment may be bulky and limit movement in the space. Before entry is permitted, it should be established that entry with breathing apparatus is possible. Any difficulty of movement within any part of the space, or any problems if any incapacitated person had to be removed from the space (as a result of breathing apparatus or lifelines or rescue harnesses being used), should be considered. Risks should be minimised, or entry prohibited.

Entering the tank with SCBA can be challenging, moving inside the tank with it and with a foggy mask even more so. EEBDs, although smaller, may not be easier to wear and their capacity is much more limited. They should definitely not be considered as a substitute for SCBA in rescue operations.

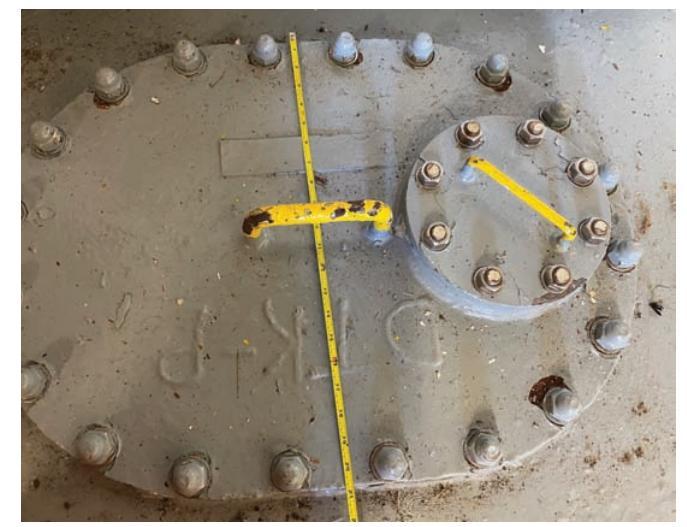
Manhole measuring less than 21 inches across (less than 530 mm)

5.1 - For access through horizontal openings, hatches or manholes, the dimensions shall be sufficient to allow a person wearing a selfcontained air-breathing apparatus and protective equipment to ascend or descend any ladder without obstruction and also provide clear opening to facilitate the hoisting of an injured person from the bottom of the space. The minimum clear opening shall not be less than 600 mm x 600 mm.

Problem: The size of the person using the SCBA can be of relevance, as can the weather: in sub-zero environments, winter clothes can add volume and make going through a manhole even more difficult. Regardless of SOLAS regulated dimension of manholes, some older ships do exhibit openings measuring less than 600 mm, which makes the entry rather difficult even without the SCBA.
